The Martian Landscape

By The Viking Lander Imaging Team

Scientific and Technical Information Office
NATIONAL AERONAUTICS AND SPACE ADMINISTRATION
Washington, D.C. 1978

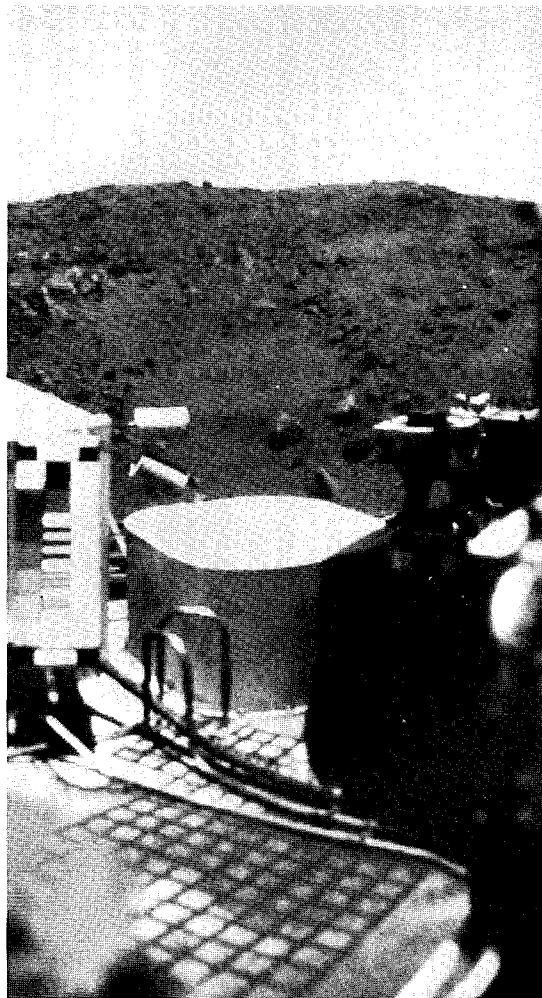
FIGURE 168

A grid had been painted on the upper deck of the Lander especially to create a distinctive background against which accumulation and movement of dust could be measured (figs. 168 and 169). In order to more clearly map the distribution of dust, parts of these two images have been rectified as though the viewer were looking straight down on the Lander grid (figs. 170 and 171). This also allows easy comparison between images acquired by the two cameras.

We recognized early the sediment spilled from sampling operations and some purposely dumped on the deck for analysis of soil properties. However, it was several months before we realized that the swirls of yellowish sediment were changing when no surface sampler activity had occurred.

The changing sediment patterns are caused by the martian wind. Why is sediment movement observed on the Lander but not in the natural scene? Several possible reasons come to mind. Surface materials may have been disaggregated during transportation to the spacecraft deck, creating finer grains easier to move. Constriction of air flow by spacecraft components may increase wind speed and turbulence. Vibration of the upper deck may cause particles to

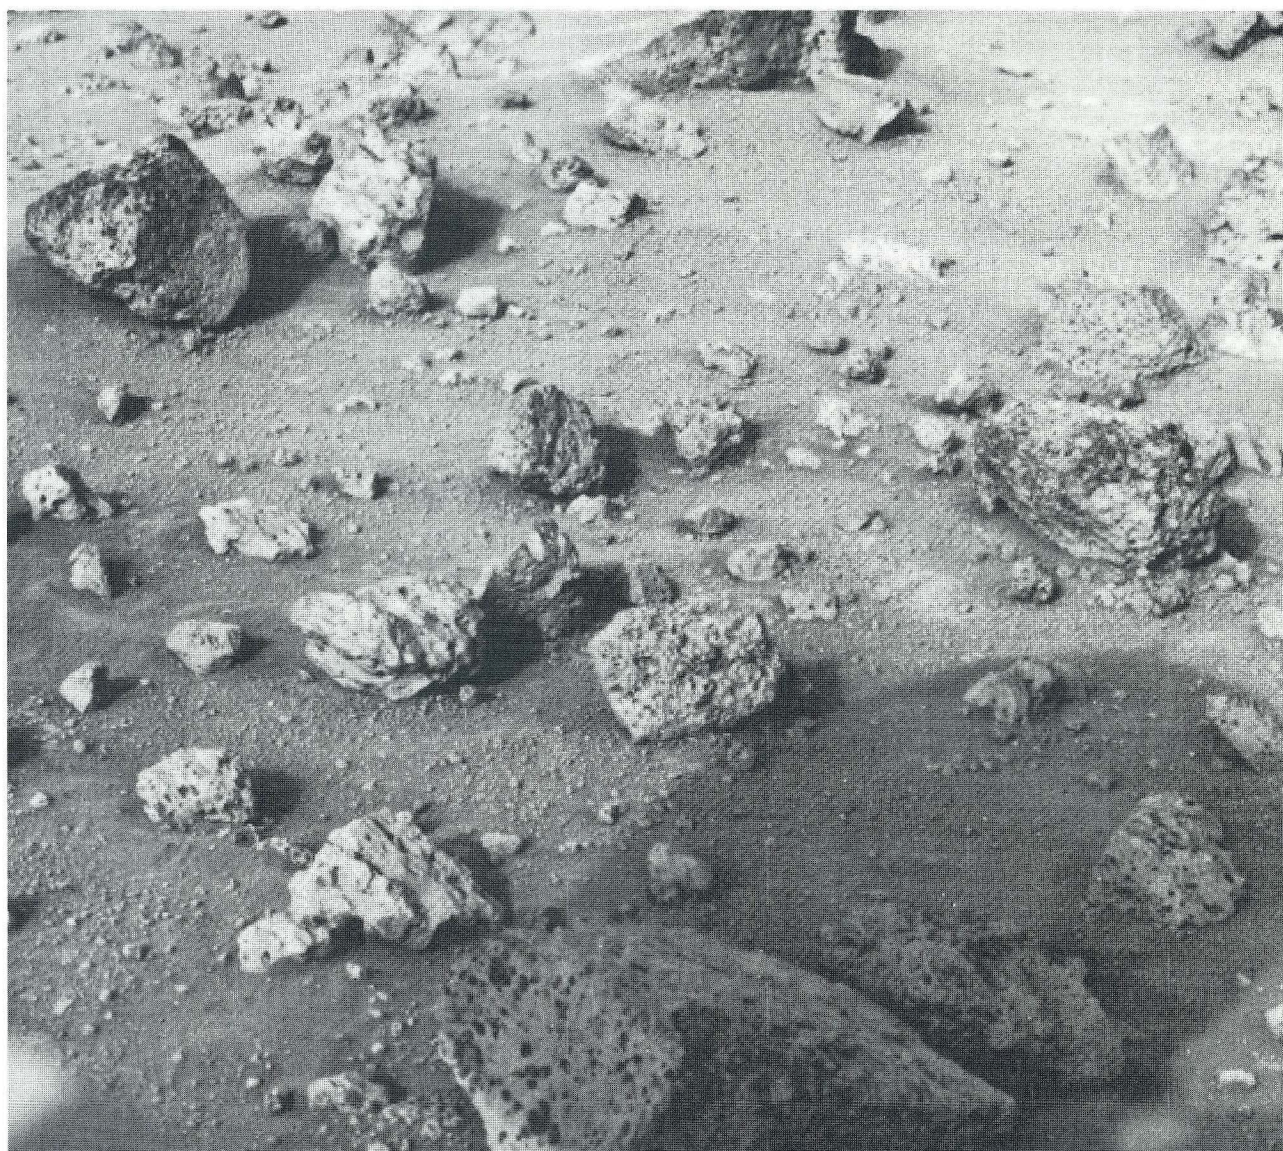
FIGURE 172

Figure 172, taken during the extended mission, is generally darker and shadows are more diffuse than equivalent images taken during the early mission. This is the result of increased atmospheric opacity and scattering of light by suspended dust particles. Note, in particular, the "soft" circular shadow of the S-band antenna.

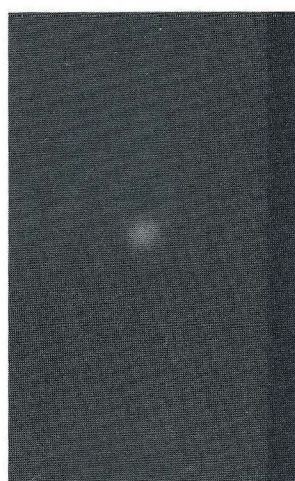
FIGURE 173

Figures 173, 174, and 175 record variations in apparent brightness of the Sun, imaged directly with the Sun diode. Because only the Sun is bright enough to be recorded, the pictures are relatively unimpressive, although scientifically useful. Figure 173 shows the Sun in a relatively clear sky. Figure 174 shows a darkening by a factor of more than 2, the Sun actually being invisible. Figure 175 shows a partial return to clear conditions.

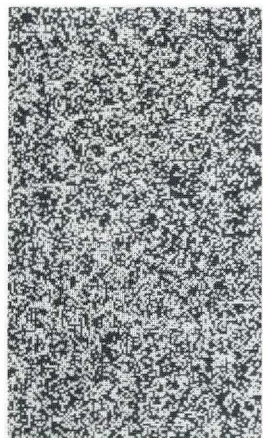
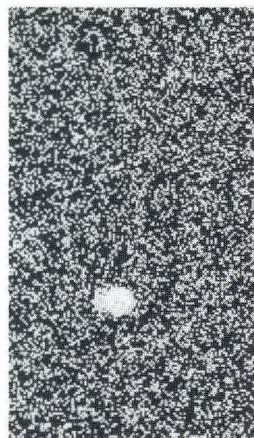
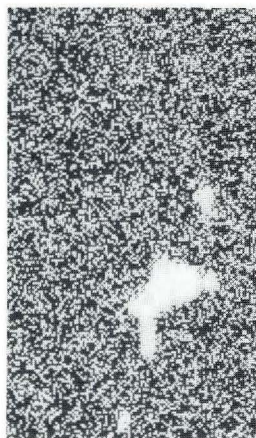
We were restricted to viewing two objects beyond Mars, Phobos, and the Sun. Figures 176 through 178 show the Sun imaged at different elevation angles. As it rises higher and the path length of light through the atmosphere decreases, the solar disc becomes brighter. Figure 176 is taken at 5:48 a.m. The Sun, about 5° above the horizon, is barely distinguishable. The speckled appearance of the sky is an artificial effect, caused by extreme enhancement of detail in a very bland scene. Figure 177 was taken at 6:12 a.m.; the elevation angle of the Sun is about 10° . Figure 178 was taken at 7:00 a.m.; the Sun is approximately 20° above the horizon. The irregular shape and secondary

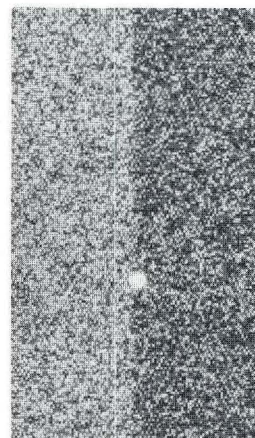
FIGURE 179

Phobos is one of two natural satellites of Mars. An irregular, cratered object about 22 km in diameter, it circles Mars approximately 1000 km above the surface every 11 hours. Although visible as no more than a bright object several pixels in diameter (fig. 179), images of Phobos proved very valuable in determining the opacity of the night sky. Color and IR reflectance values of the integrated disc were clues to the satellite's chemical composition. The spectral data best fit that of carbonaceous chondrite, a variety of meteorite believed to represent primitive solar system material.

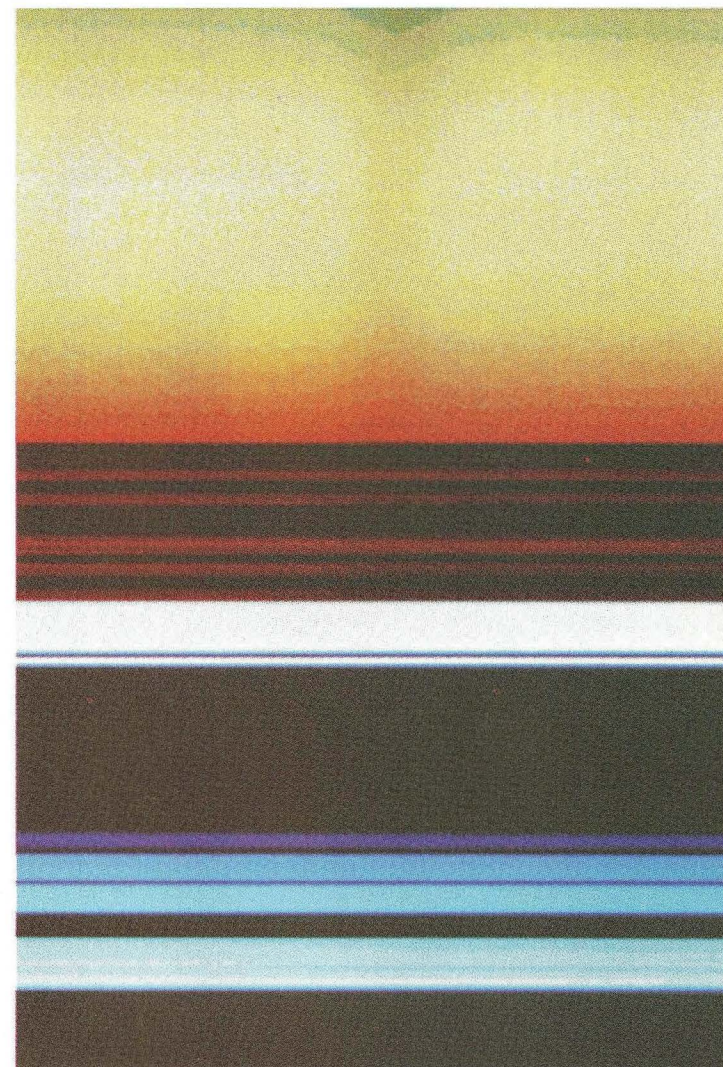
FIGURE 180

Possibly the most unusual of all Viking Lander pictures records the passage of Phobos' shadow during a solar eclipse (fig. 180). On Earth the apparent size of the Moon is exactly the same as that of the much larger but more distant Sun. Consequently, direct sunlight is completely blocked out during a total solar eclipse. On Mars, Phobos covers only a quarter of the solar disc. However, passage of the penumbral shadow causes a general drop in light level that is instrumentally detectable. Figure 180 is a repeated-line scan image looking back across Viking Lander 1. The colors have been distorted purposely to enhance detail. The blue and white horizontal

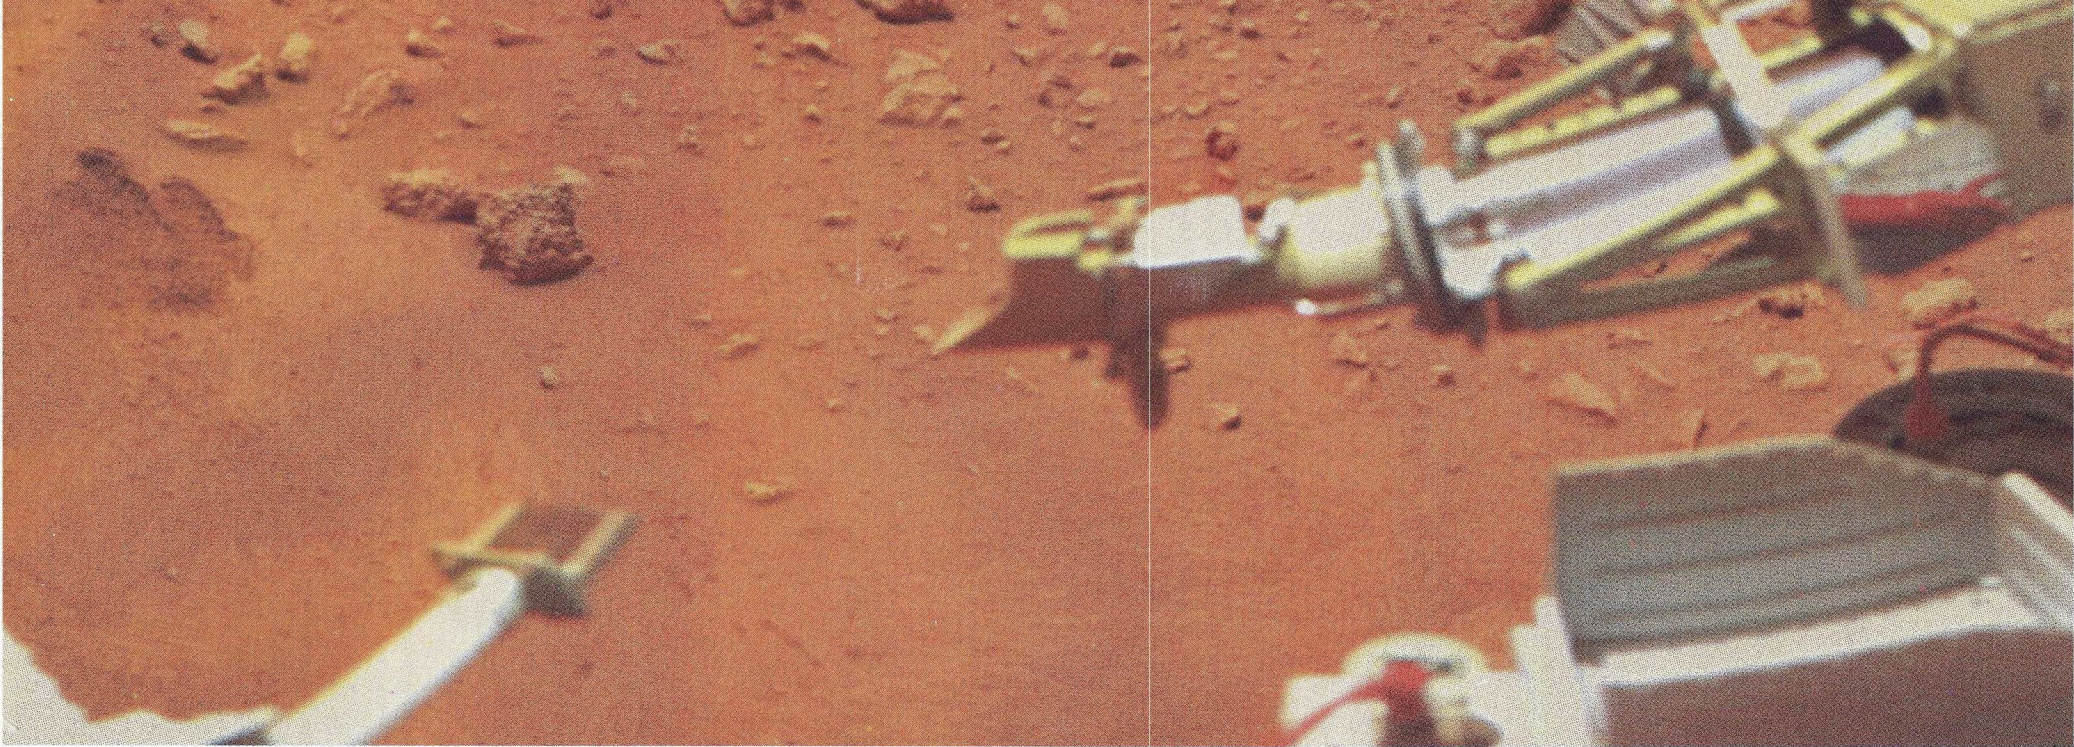
FIGURE 181

Figures 181, 182, and 183 illustrate the range of possible color reconstructions. All three pictures are based on the same camera data. The sampling area at the Viking 1 site is shown. Two trenches in the Sandy Flats site, the first to be dug,

are shown at the far left. Figure 181 is produced by using only visible color information, making no allowance for IR leaks. The scene has a reddish or orangeish cast. Figure 182 is constructed by incorporating data from an accompanying IR picture and using the spacecraft's test charts, in this way accounting for out-of-band contributions and atmospheric colorations. The scene is shown as it might appear "on Earth." For example, if you could pick up one of the boulders and transport it to your back yard, this is the color you would observe. Note that, relative to figure 181, the reddish tint is subdued, replaced with a brown hue. Figure 183 shows the scene as it would appear "on Mars." The yellowish cast of sunlight filtering through the atmospheric dust imparts a similar yellowish hue to the entire scene.

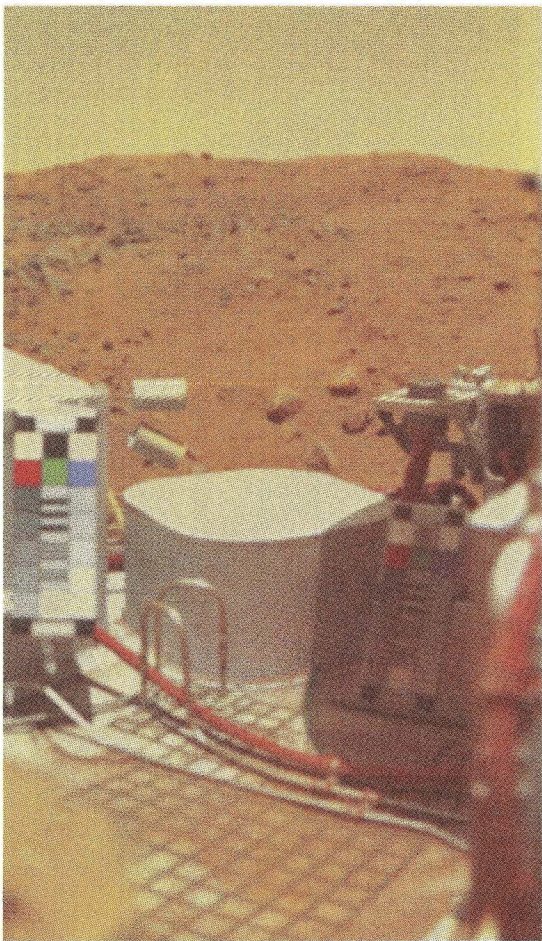
FIGURE 184

Figure 184 is a view looking across Lander 1. Two test charts are visible. The one at the left is directly illuminated; the colors of the red, green, and blue color chips are accurately rendered. The test chart to the right is in shadow and, consequently, of little value for color calibration.

by reading progressively smaller symbols on an eye chart. A color picture of a test chart is shown in figure 184.

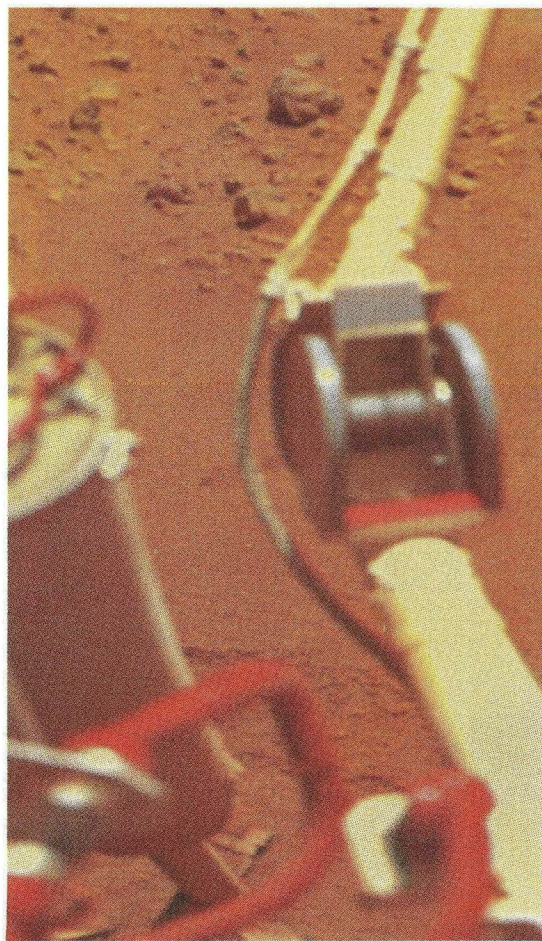
FIGURE 185

Figure 185 shows the landscape to the left of the region in figures 181 to 183. Drifts of sediment are visible in the distance. Footpad 2, at the bottom of the image, is buried by yellowish-brown soil.

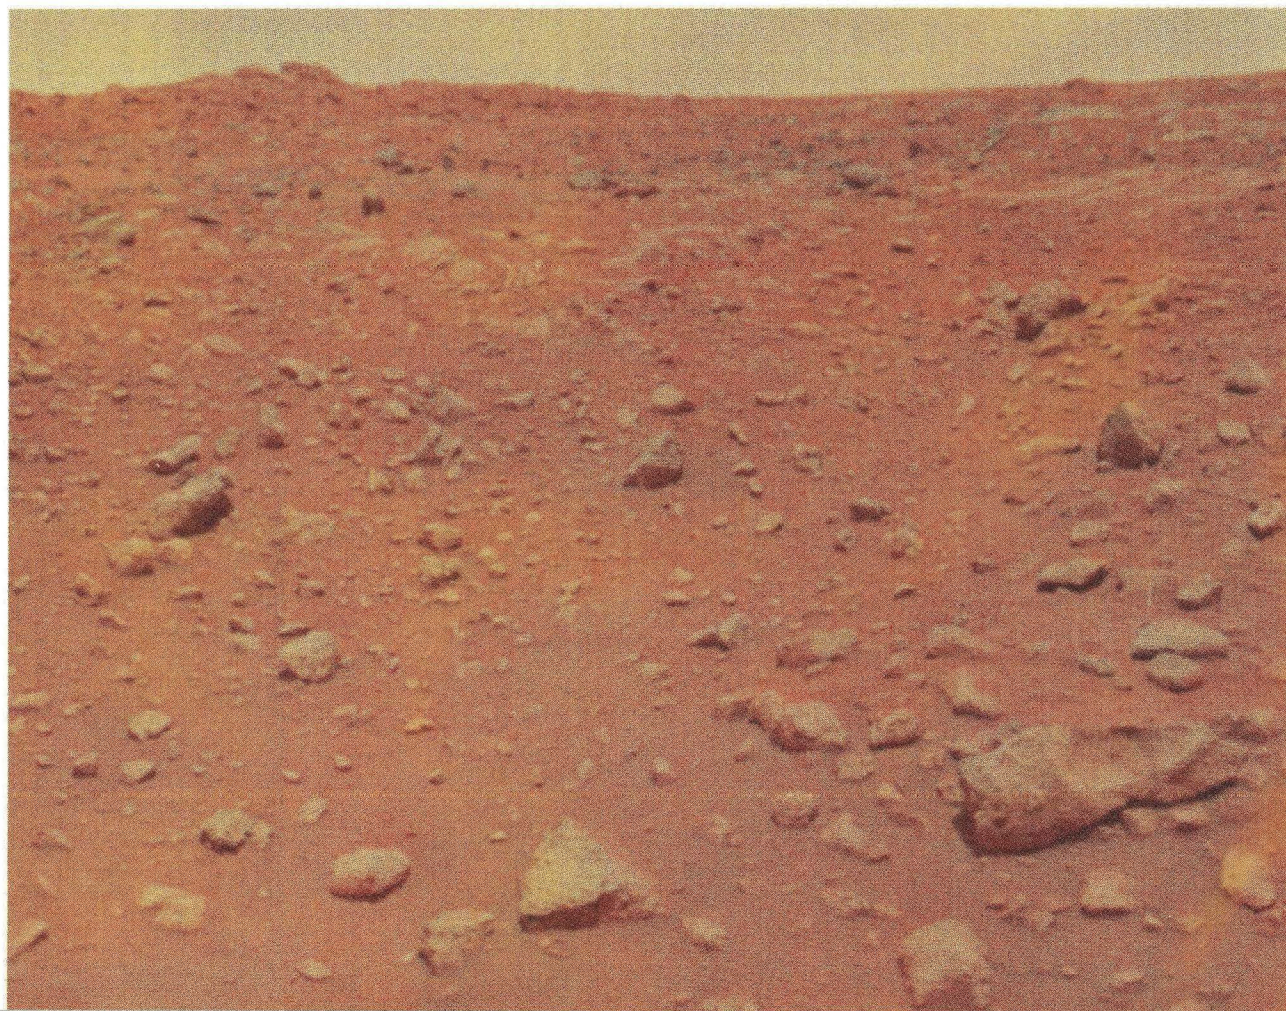
FIGURE 186

Figure 186 is a historic picture, the first color image to be taken on the surface of Mars. Because there was no accompanying IR image, it is not possible to compensate for irregularities in the camera color filters. The color has the same relative quality as in figure 181.

In order to correct for the out-of-band spectral leaks in the color filters within the camera it is necessary to have access to both a color and an infrared (IR) picture taken at the same time. Only in that way can the IR contributions to the visible color, a result of camera filter design, be assessed. For the many color pictures taken without an IR companion (e.g., figs. 186, 192, and 198) detailed calibration is not possible. Instead, the

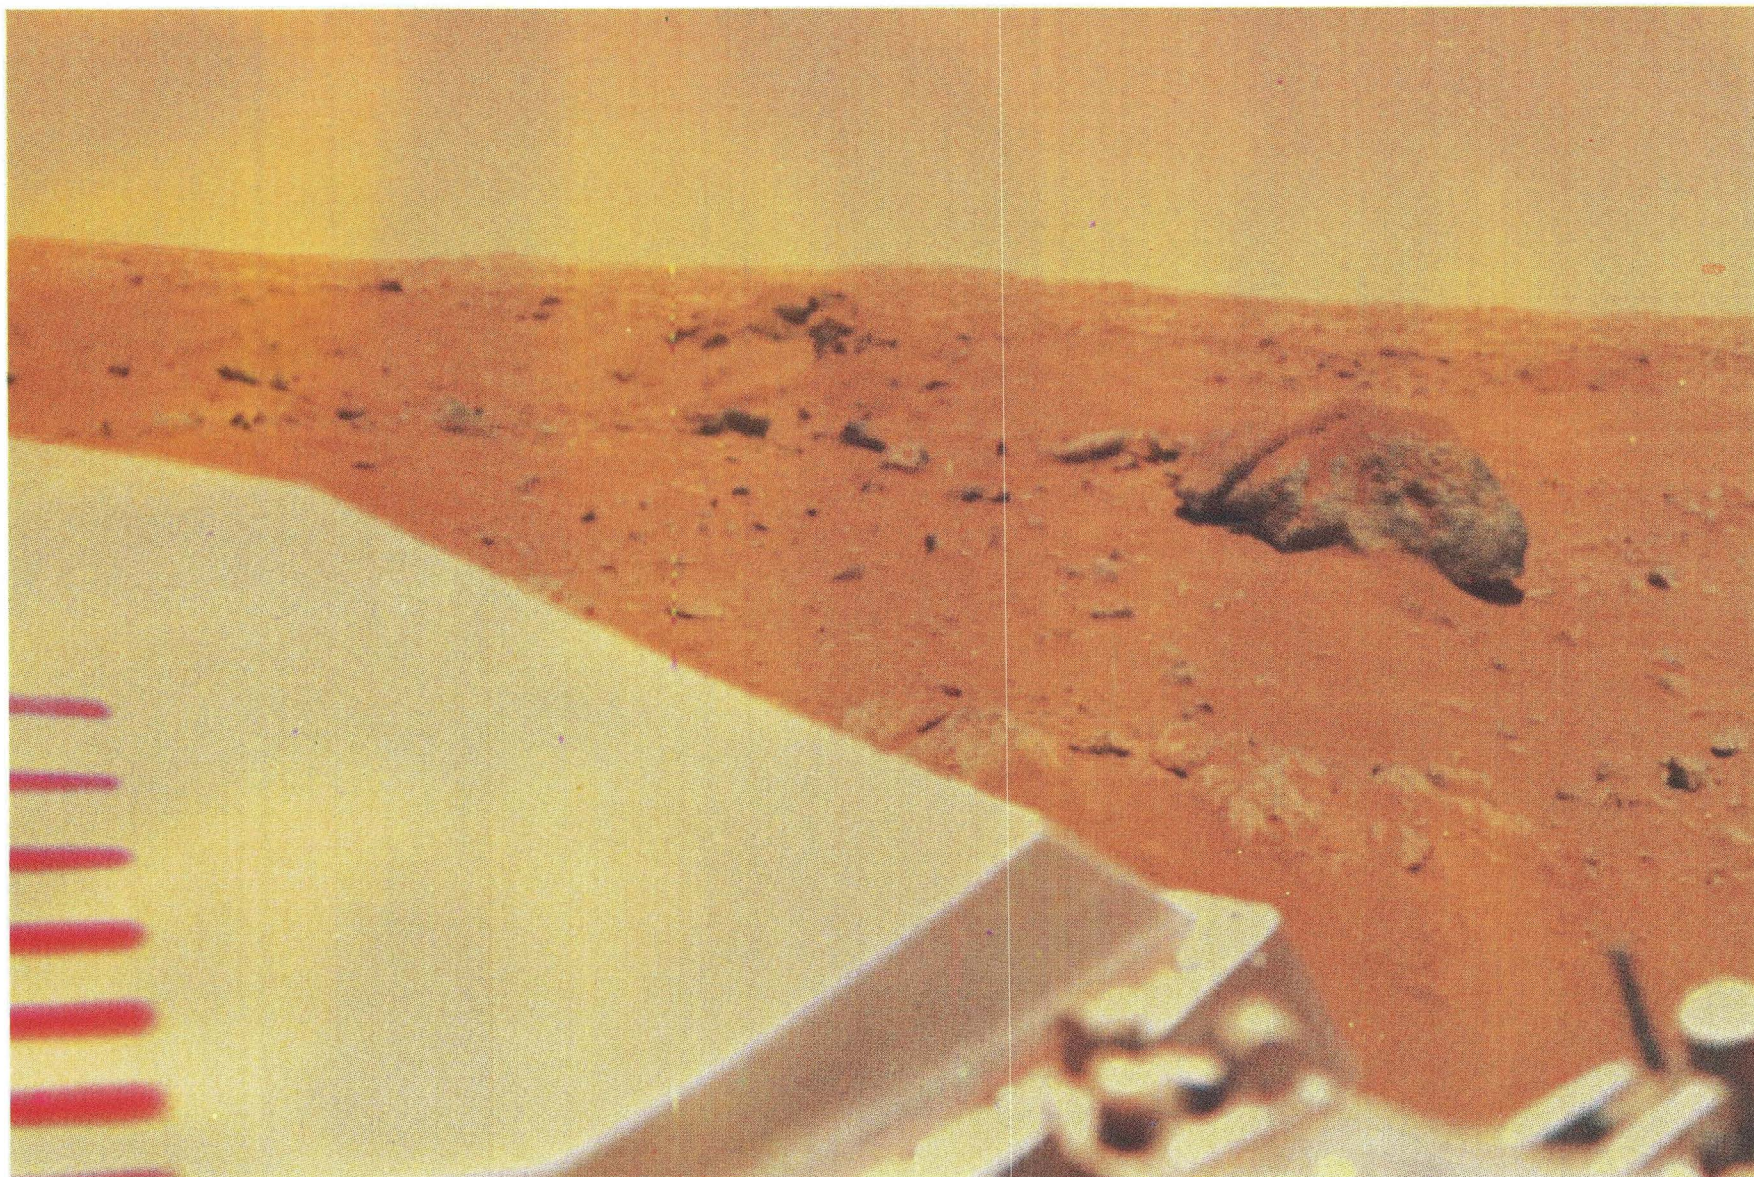
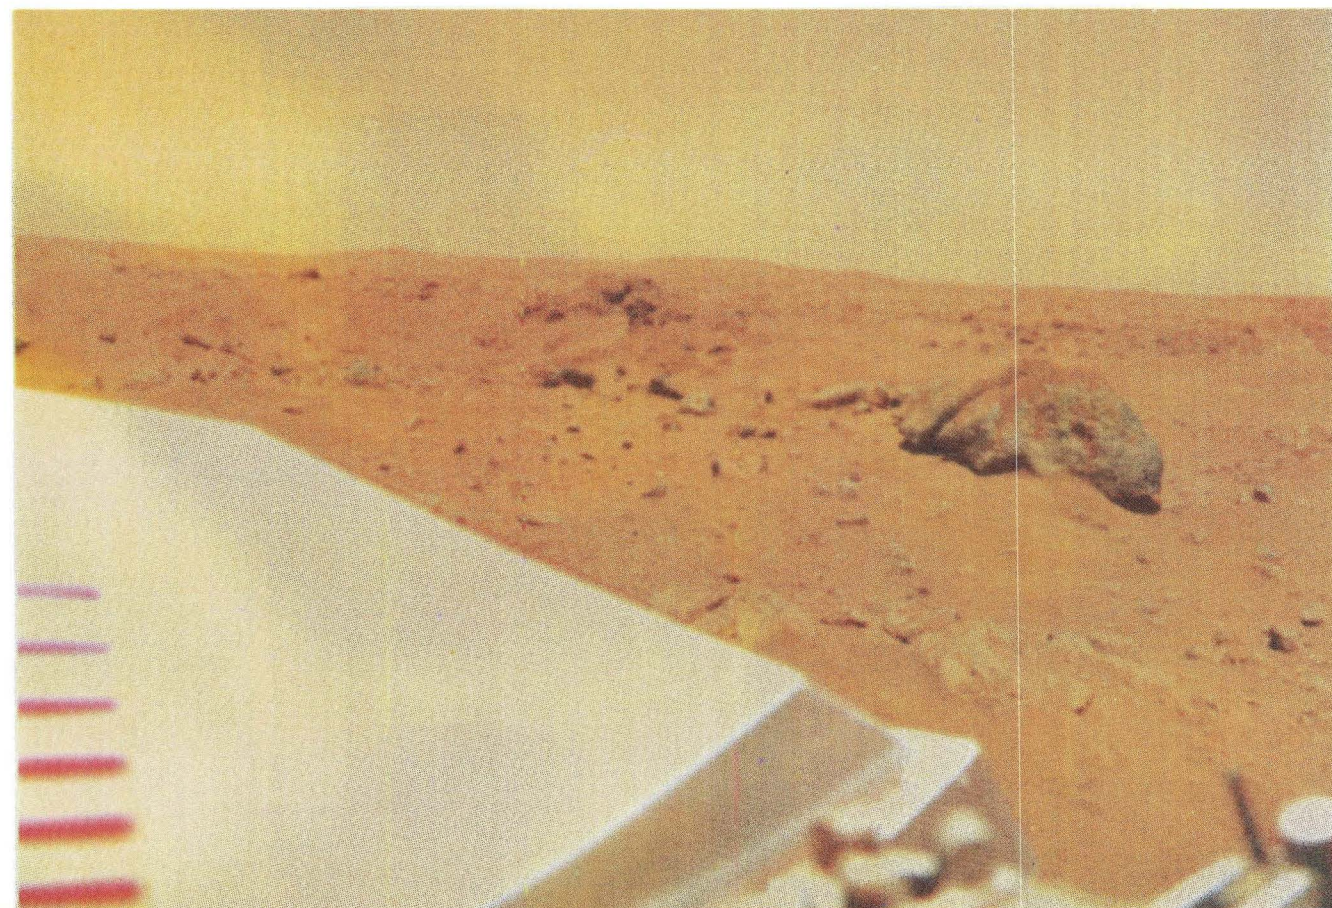
Figure 187 (as on Mars) and figure 188 (as on Earth) show the landscape in the vicinity of the large dark rock, "Big Joe." Note that the boulder has a crown of fine-grained material. Exactly how this mantle formed is a puzzle. It may be an erosional remnant of a dust layer which formerly covered the region with a thickness of a meter or more.

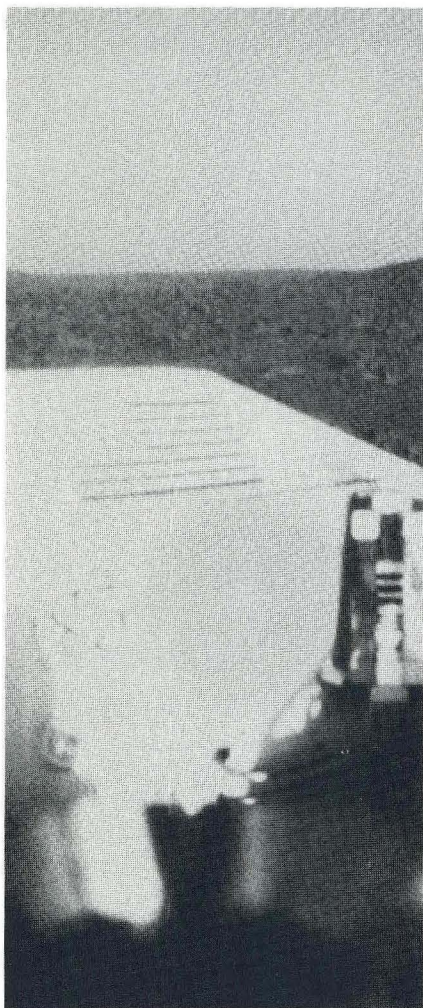
FIGURE 189

colors are indicated by the violet hue of the blue color chip on the test chart. The relative differences in reflectance that yield a color image are illustrated by the three constituent images taken in blue light (fig. 189), green light (fig. 190), and red light (fig. 191).

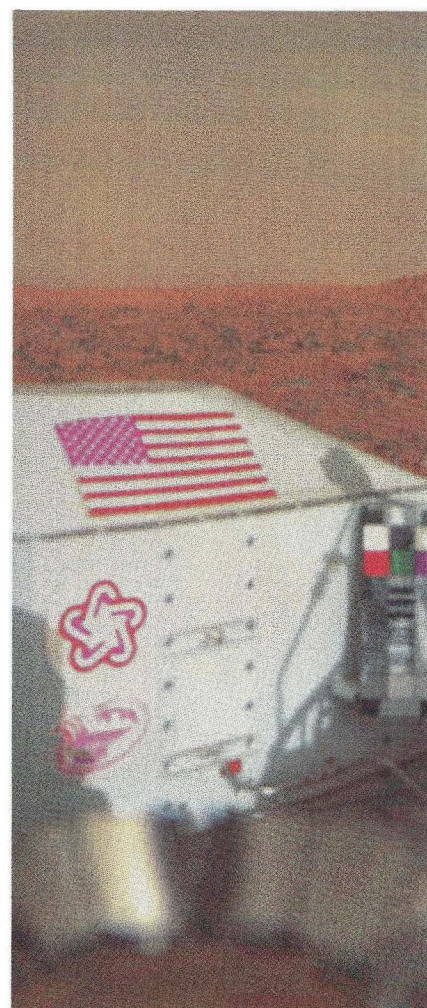
FIGURE 192

Figure 192, taken early in the Viking 1 mission, was nicknamed "The American Flag Picture" even before it was taken. During the final months of preparation before the landing NASA managers took exception to our decision to feature only the Mars surface in the first few color pictures. In particular, they emphasized the popular appeal of a color picture looking back across the spacecraft, the American flag in the foreground and the martian horizon in the distance. We temporized; they insisted. Figure 192 was the result. The photograph is both pictorially attractive and scientifically useful. The bright ridge in the distance, part of the crater rim described in figures 77, 78, and 79, catches the morning Sun. Difficulties in precisely balancing the

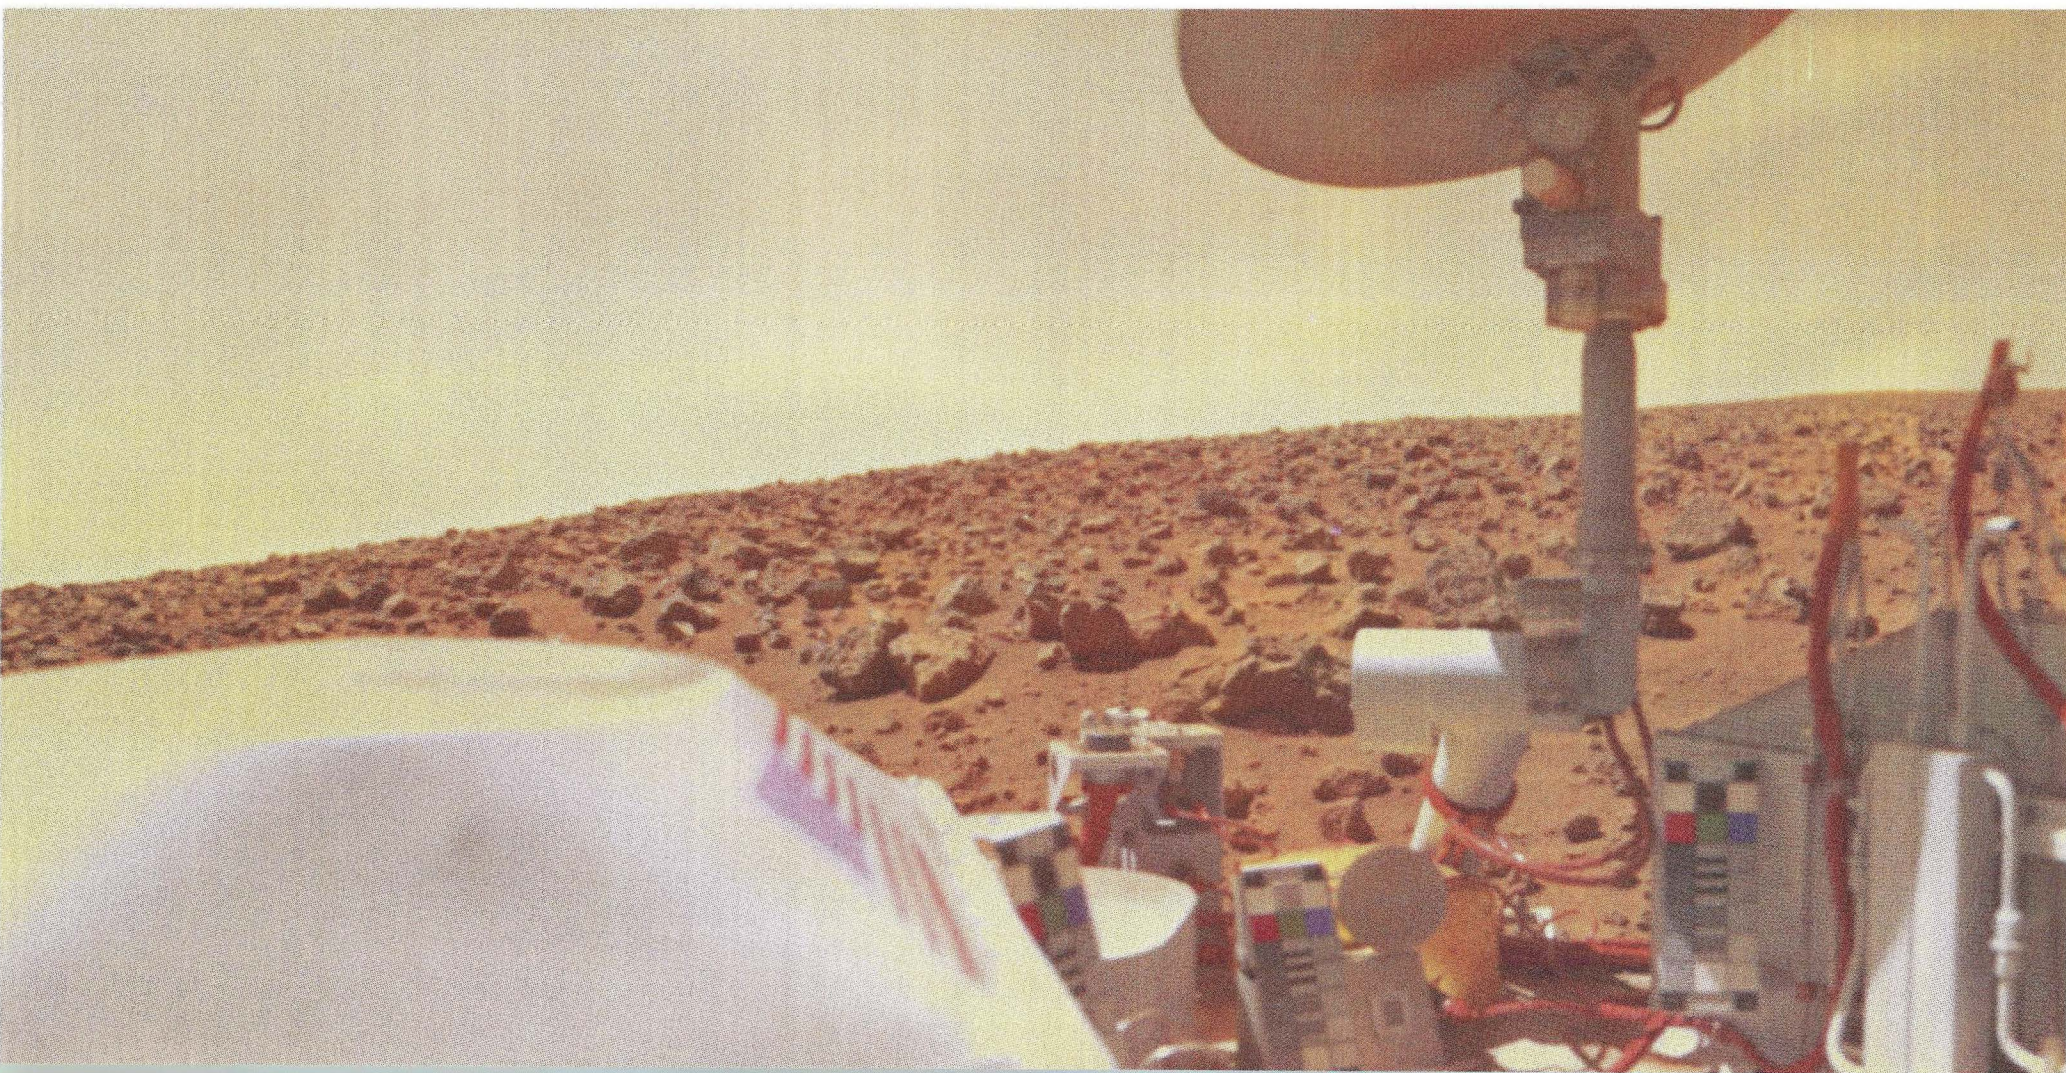
FIGURE 193

Figure 193 is a view looking back across Lander 2. Dark boulders are prominent against the yellowish-brown soil, standing like regularly deployed sentinels out to the far horizon.

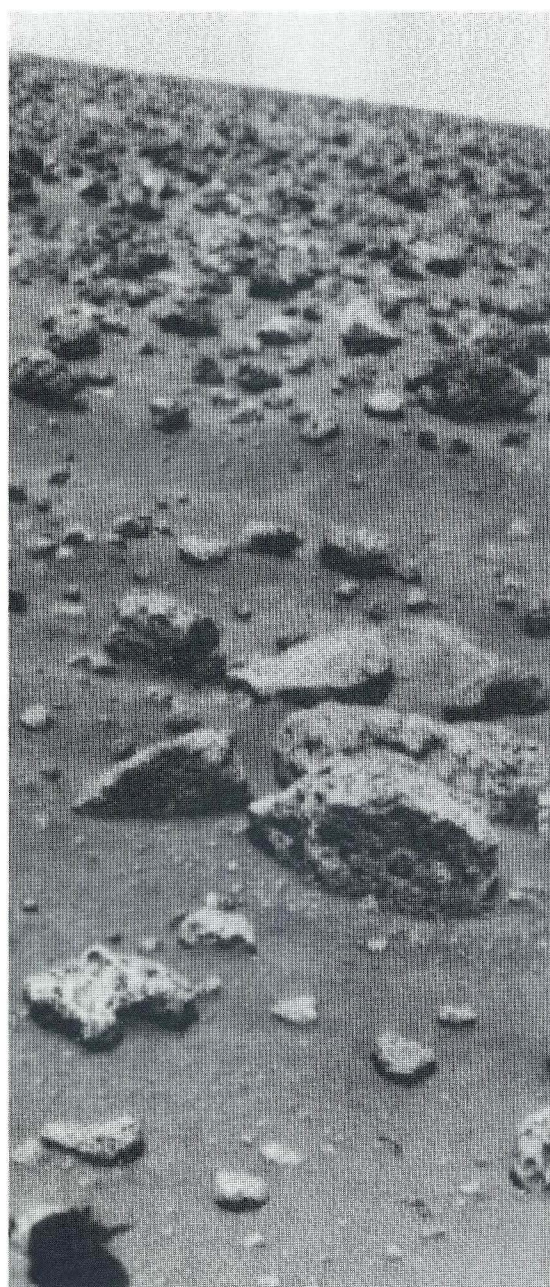
FIGURE 194

In the course of the martian year an important surface change was observed at the Viking 2 site. During the winter months a thin layer of frost formed. This is documented by comparing two black-and-white pictures, the first taken early in the mission in late martian

summer (fig. 194), and the second taken months later in late martian winter (fig. 195). Patches of receding frost are visible in the latter picture. During the height of winter, frost probably covered the entire surface. Figure 196 is a color image of the frost, looking across the spacecraft. The colors purposely have been distorted slightly to enhance color contrast.

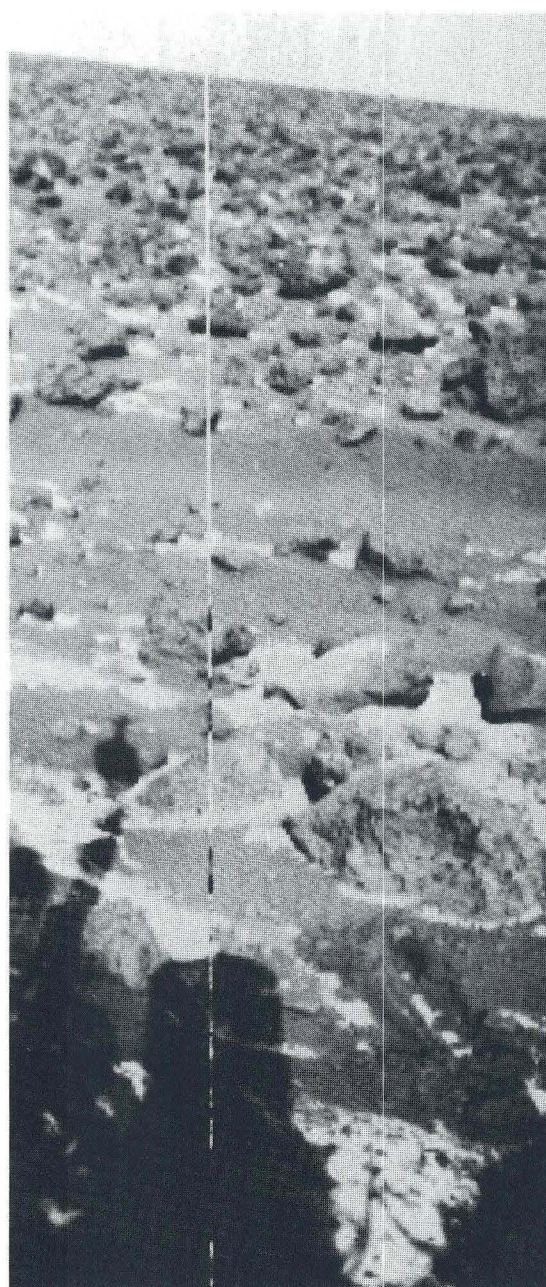
FIGURE 195

The frost persists at temperatures higher than those required for frozen carbon dioxide (dry ice). It may be water ice or a carbon dioxide clathrate, a crystalline mixture of H_2O and CO_2 .

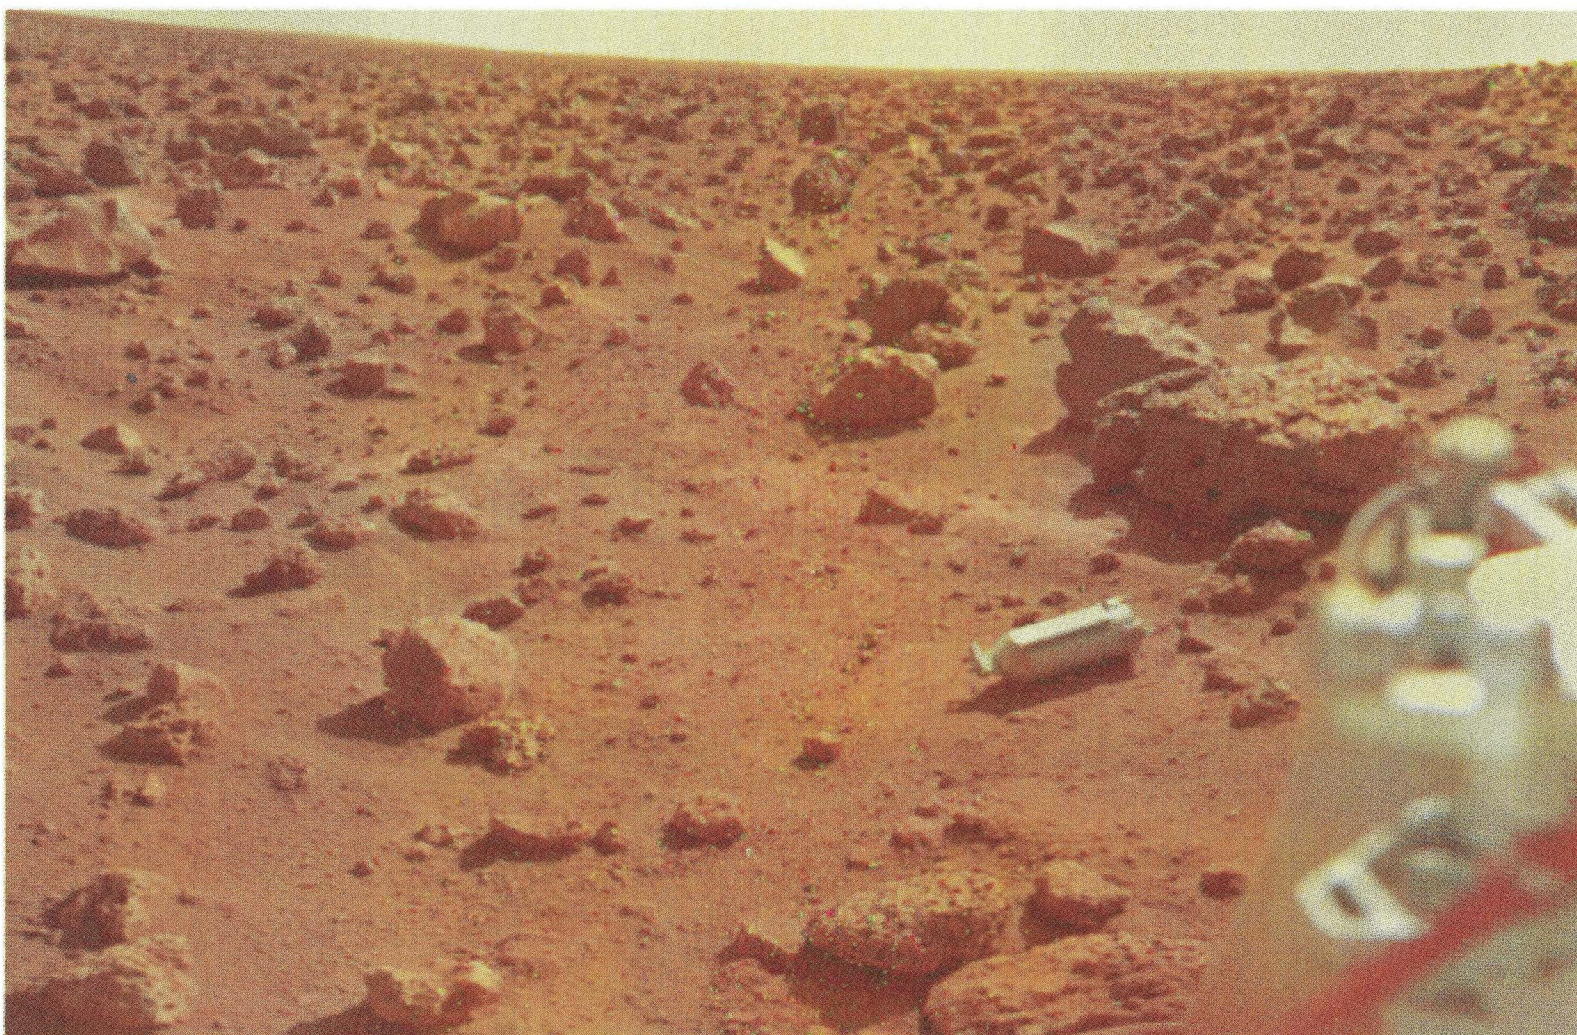
FIGURE 197

The region in front of Lander 2 was photographed many times in color. In figure 197 the surface sampler shroud contrasts sharply with the remainder of the scene. Dust clings to the surface of footpad 3 and the lower part of the leg strut.

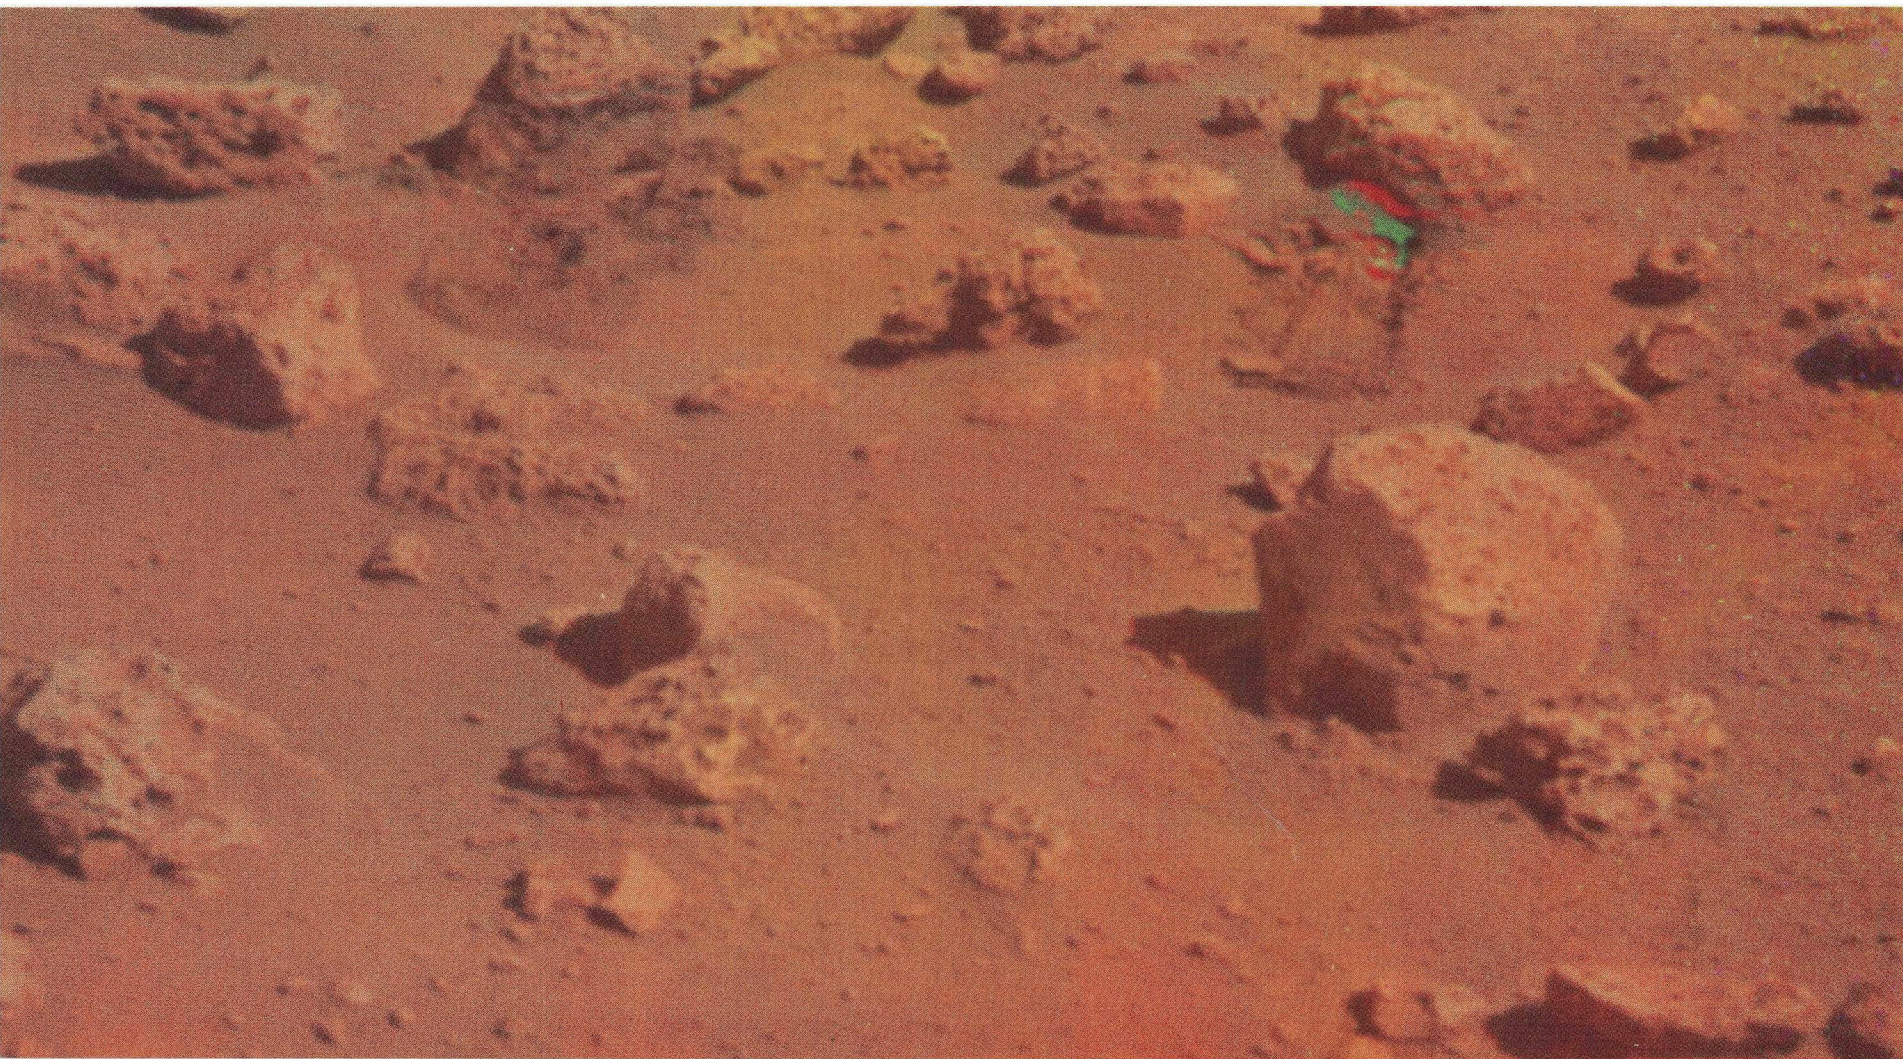
FIGURE 198

Figure 198 illustrates the operational versatility of the Viking cameras. By generating special commands we were able to combine operational modes in ways never envisioned by the original designers. In this picture the 0.12° color diodes were stepped at 0.04° intervals instead of the usual 0.12° intervals. The result is a "high-resolution" color image in which spatial resolution approaches that of a black-and-white picture for which both aperture and stepping angle are 0.04° . The red and green patches near the rock in the upper right occur because the three blue, green, and red images that comprise the color picture were taken on successive days. In the intervening period the sampling shovel disturbed the soil. False colors result primarily from differences in shadow
